Pre-vegetated Coir Achieves Rapid Results in Reconstructed Stormwater Channel

by Paul B. Hook, PhD.

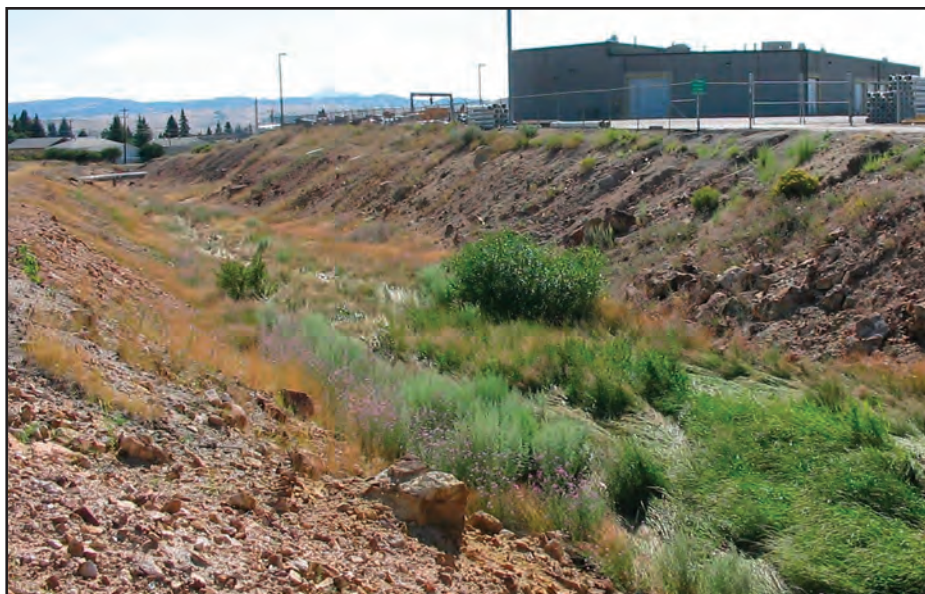
The Butte Metro Storm Drain before reconstruction and revegetation.

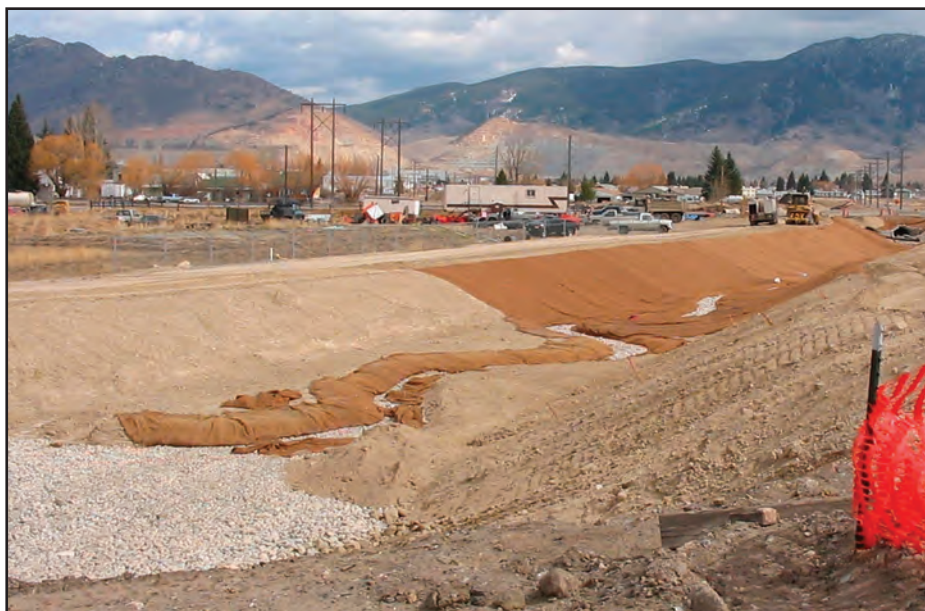
Final stages of channel reconstruction. One foot of gravel covers the entire channel bottom (lower left). The pilot channel and "floodplain" were created by placing one foot of soil over the gravel except in the meandering pilot channel (center). Soil was covered with erosion control fabric after seeding (right).

laid across the entire channel bed. Soil was laid over the entire channel, one ft deep across the bottom and two ft deep on the side slopes. While soil was placed, a four-ft wide, one-ft deep pilot channel with 1:1 sideslopes was built into the bottom in a meandering pattern, leaving the gravel exposed as a simulated streambed. Soil was protected with a coconut fiber erosion control fabric, which was wrapped beneath the soil at the pilot channel bank.

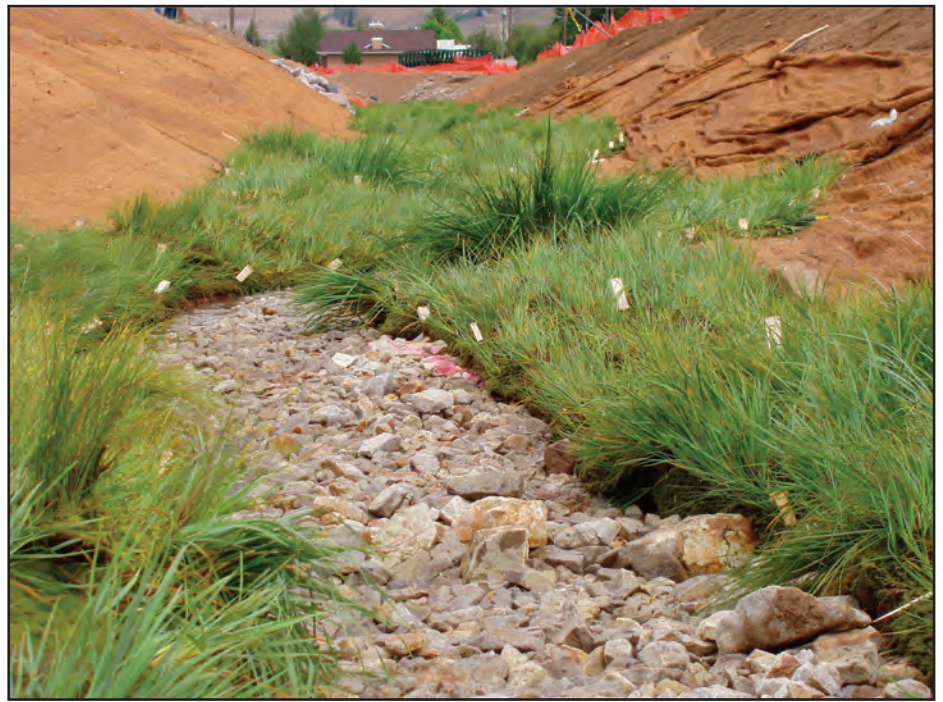
Prevegetated coir immediately after installation. Cover of native sedges and rushes is already quite dense, though not complete, and plants are primed for vigorous root growth.

The prevegetated coir product used, Native Sod Solutions' Wetland Sod, consists of a heavy coir blanket measuring roughly 3.3 by 16.4 ft and planted with one to three wetland species. The sedges, rushes, bulrushes, and grasses are planted directly into the coir blanket and grown hydroponically in a nursery until ready to install. When delivered, root systems are well developed and shoot cover is relatively dense.

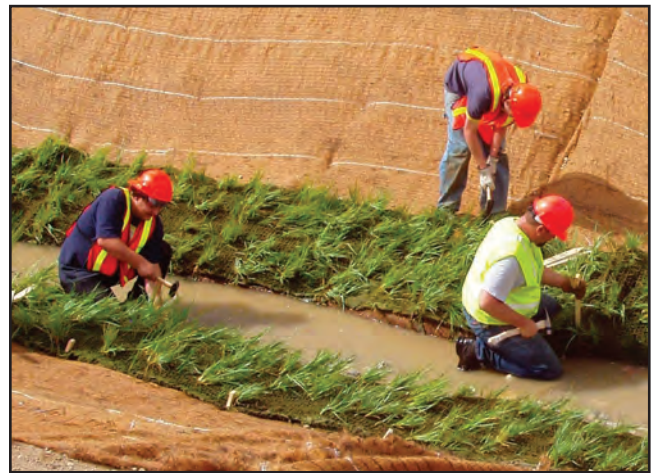
Butte-Silver Bow County crews stake prevegetated coir in place in August, 2004.

Prevegetated coir pieces are delivered in rolls about the size of a 55-gallon barrel and weighing either side of 150 pounds depending on degree of saturation. Pieces are unrolled like lawn sod during installation. For this project, each piece was laid down lengthwise on the pilot channel bank, with one edge near the toe of the bank and the other on the flat bench of the larger channel bottom. The coir mats were pinned in place with ten wooden stakes each to secure them until fully rooted. The coir blanket contributes to temporary erosion control but is mainly a growth medium and physical “carrier” for the plants. Erosion protection relies on full rooting and robust shoot growth; it’s the plants, not the coir, that provide the real, permanent erosion control.

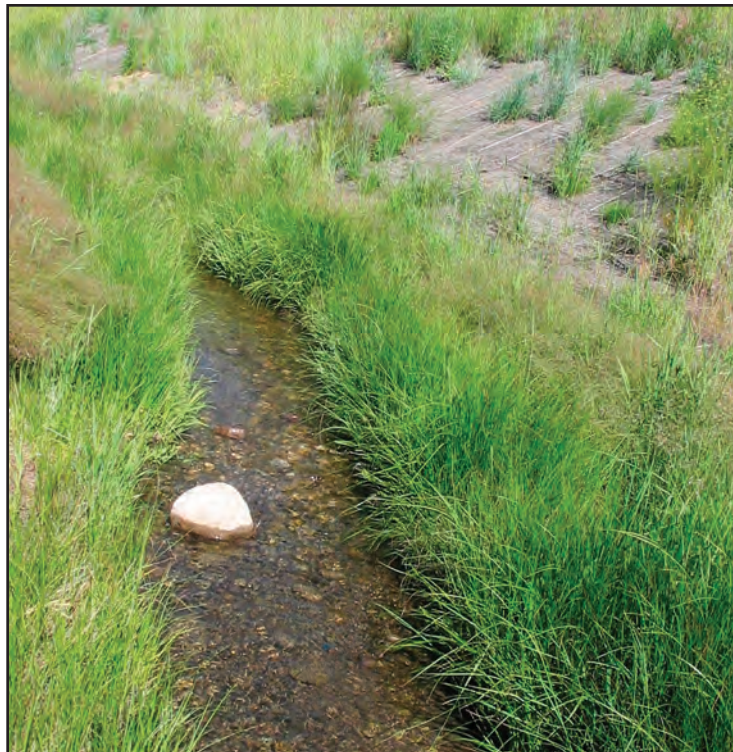
Revegetated channel in July, 2005, less than one year after installation.

There have been several significant storm runoff events since the project was completed, including several soon after revegetation. According to Tom Malloy, Reclamation Manager for the Butte-Silver Bow Planning Department, water in the Metro Storm Drain was several feet deep during one event. The areas planted with prevegetated coir were inspected after runoff events and were found to have stood up well to the flows. In 2005, areas planted with prevegetated coir were firmly rooted and had a dense, lush cover.
