## South Fork Clearwater River Watershed Restoration Project – Kirtner Property

Watershed: **South Fork Clearwater River**

Project Status: **Complete; maintenance and monitoring underway**

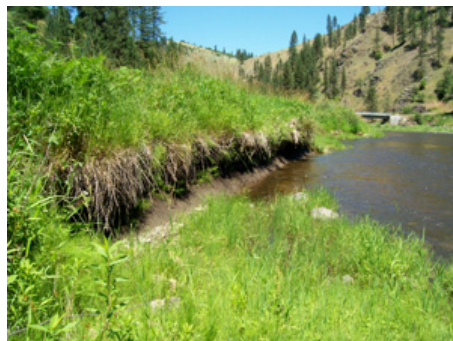
Previous Conditions	<p>The stream banks are steep and actively eroding. Limited woody vegetation exists on the banks and the addition of fill material on the banks have caused hydrologic changes in the flow which is also contributing to bank erosion.</p>

Description	<p>The South Fork Clearwater River (SF CWR) Riparian Restoration Project is designed under the guidance of the SF CWR Watershed Advisory Group (WAG) and the SF CWR Total Maximum Daily Load (TMDL), and represents activities identified in the SF CWR TMDL Implementation Plan. Riparian restoration included the re-sloping and stabilization of an estimated 600 feet of unstable bank and the re-vegetation of approximately 3,000 square feet of variable width buffer. Bank stabilization techniques included the excavation and re-sloping of the stream bank and the installation of wetland sod mats and erosion control fabric. Native plants were planted to provide additional stabilization.</p> <p>Bank stabilization will reduce sediment loading within SF CWR and the re-growth of the riparian vegetation will provide shade, leading to a decrease in elevated summer water temperatures. This is a critical target area for sediment reduction and temperature due to the intensive impacts from agriculture, ranching and residential development in the watershed.</p>
